**FIRST EVALUATION OF THE RETROFITTED SCR AT THE COAL
FIRED SOMERSET GENERATING STATION**

Presented to
Electric Power 2001 Conference
March 20 – 22
Baltimore Convention Center
Baltimore, Maryland

Abstract:

The AES Somerset SCR system has operated through almost two (2) ozone seasons, eight (8) months, since retrofit installation of the selective catalytic reduction system in 1999. During a recent scheduled outage a thorough inspection of the units was conducted. Photographs taken are presented. Previous to this inspection, catalyst sample coupons were removed and returned to the catalyst supplier for evaluation. This evaluation included catalyst activity, SO₂ to SO₃ oxidation rates, physical properties and a quantitative analysis of the catalyst for accumulated materials. The results of these evaluations are presented and discussed.

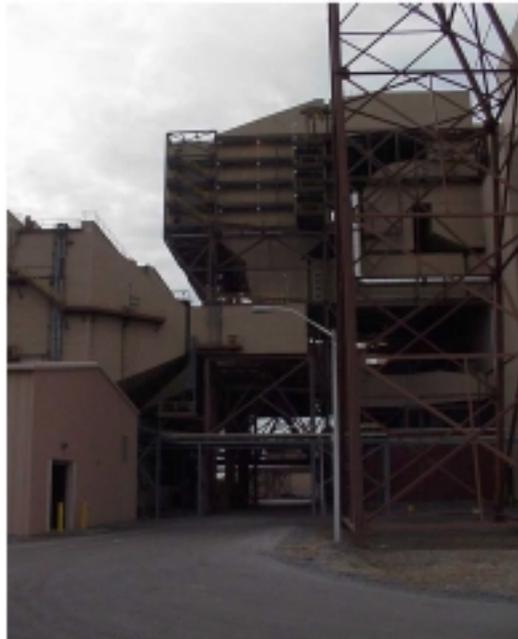
Plate 1: SCR System Facing West

The SCR system is shown in Plate 1. The boiler is North (right) with the stack being South (left). The SCR reactor is split by one wall into a west (A) and an East (B) compartment, one train for each of the two (2) air preheaters.

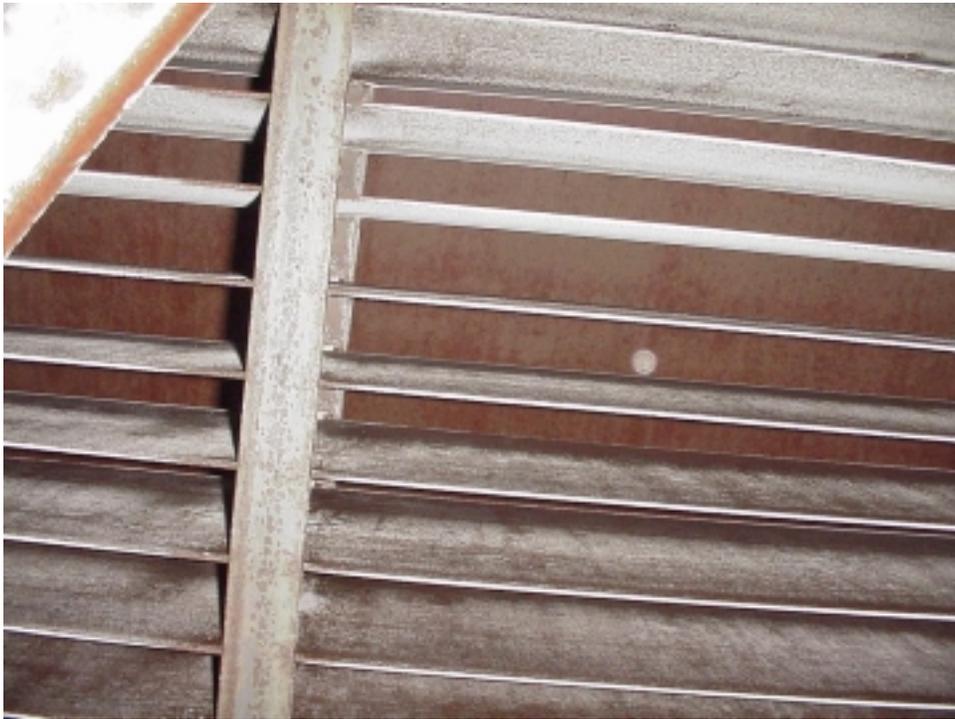
Plate 2: SCR Inlet Turning Vanes

The SCR design had considerable number of plates in the flue gas stream. These plates served several purposes. They helped to straighten, turn and guide the flow. They also form the damper louvers of the SCR bypass flue design. SCR isolation has a damper with double louvers to seal the bypass and single louver isolation dampers at the inlet and outlet of the SCR reactor. The reactor inlet gas turning vanes are shown in Plate 2. Their appearance is that of clean surfaces with no ash on the surfaces or within the operating mechanism. All plates in the gas stream were observed to have a similar appearance.

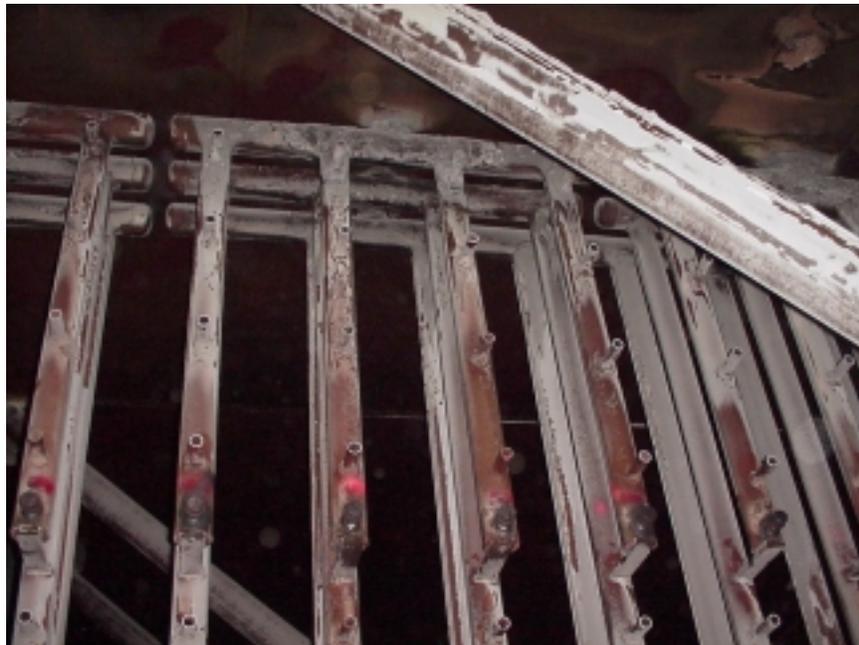
Plate 3: Ammonia Injection Grid

Each flue gas train had a separate ammonia injection grid with 21 independently adjustable injection zones; seven zones horizontally and three vertically. Plate 3 shows a representative portion of the injection grid. The dust is of a powder consistency and principally on horizontal surfaces. Design layout in conventional boilers usually lends the AIG plane to be horizontal in up flue gas flow or vertically in horizontal gas flow. Placement of the AIG in a horizontal flow area protects it from falling dust that can accumulate in the nozzles. Some nozzle fouling was observed. There was some red substance near and below some of the nozzles. This can be observed in the plate. It was conjectured that this might be some ferric based residue although its exact composition and origin was not determined. This has been noticed in other installations.

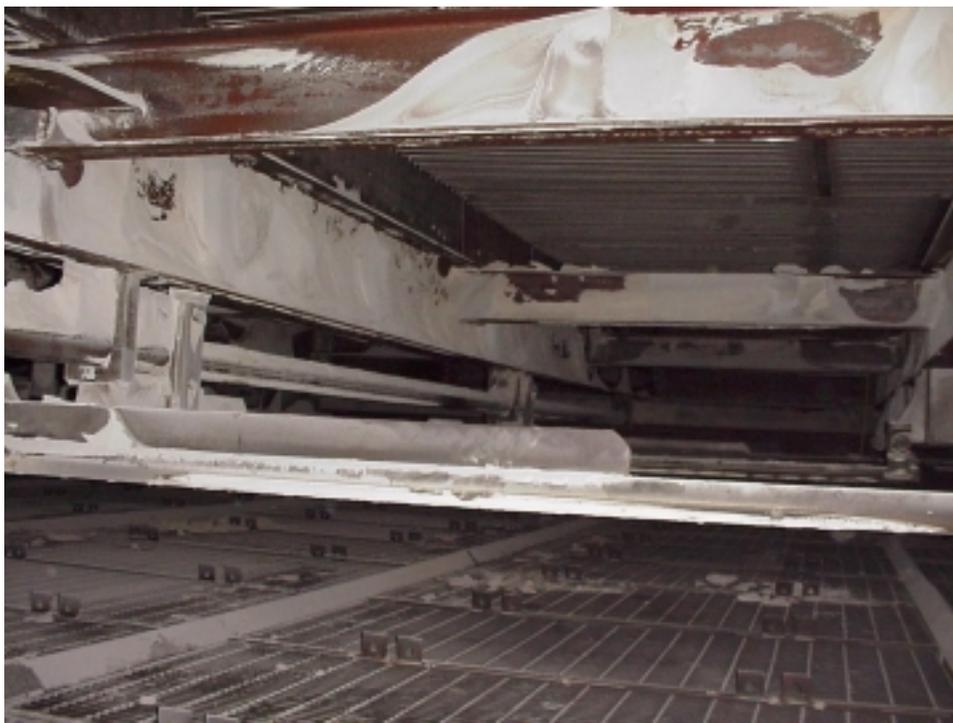
Plate 4: The SCR Reactor Cavity

The general condition of the catalyst cavity was good. Again, dust was observed only on horizontal surfaces and was very loose. Some small dust piles were noted on the catalyst but these were always just below beams or other obstructions that collected dust and it is concluded that these piles are nothing more than dust that fell from above at or after shutdown. The general condition of the reactor can be seen in Plate 4. Dust on the horizontal surfaces is

easily observed. It was found to be very loose and dry and an individual could blow it off its perch. The remainder of the reactor is very clean. Rake type half track steam soot blowers are used on a periodic basis to keep the catalyst and reactor clean. The soot blowers can be seen in Plate 4.

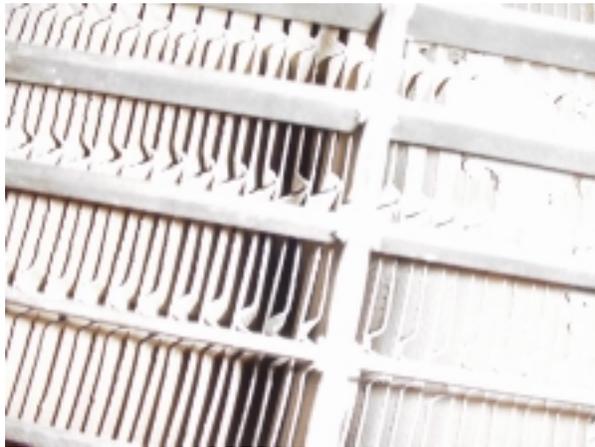
Plate 5: SCR Catalyst

Several photographs of the catalyst were taken. Plates 5, 6 and 7 being representative of what was generally found. Plate 5 shows the general clean condition of the catalyst. In the upper

center of Plate 6 a small loose pile of dust can be observed. No pluggage was observed. Close visual examination uncovered no signs of erosion. The catalyst, in general, looked pristine. It retained its original yellow coloring except for a slight dusting of gray tinge. This is typical of the general catalyst conditions. Unfortunately the lighting for the photographs was not the best and colors are thus not true.

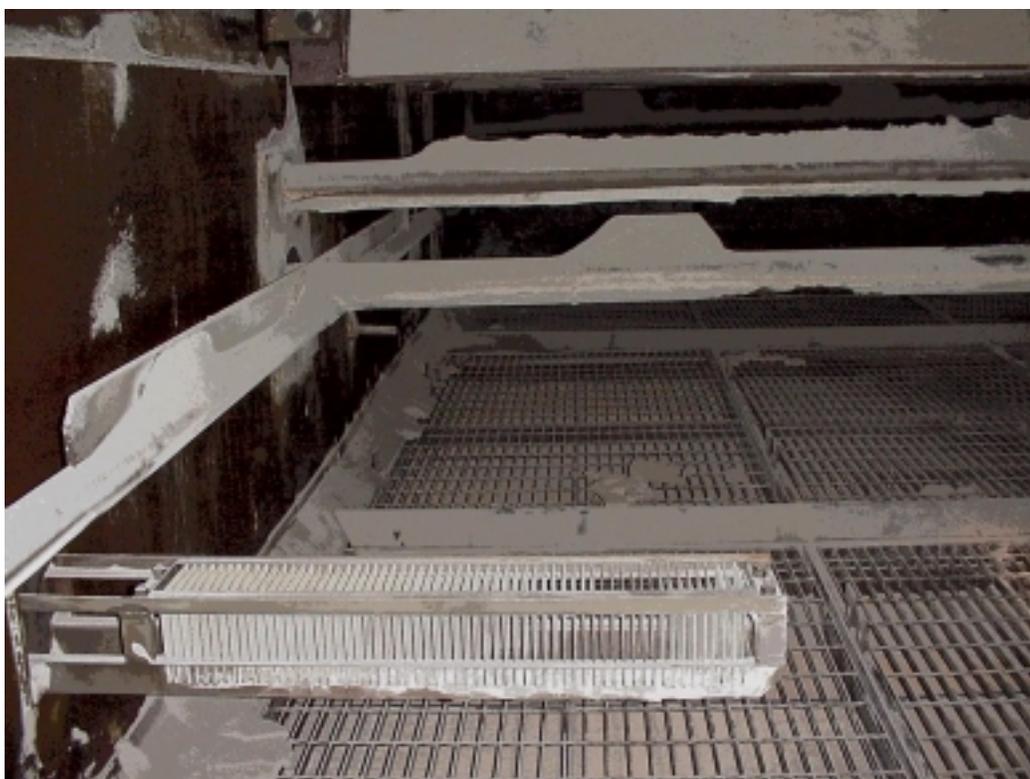
Plate 8: Catalyst Test Coupons in Cassette

Four (4) catalyst cassettes each containing about 60 catalyst sample coupons, as that shown in Plate 8, were installed into the reactor. One cassette was installed at each reactor train inlet and each reactor train outlet. At the end of the first 8 months of operation two coupons were taken from each cassette and sent to BHK for testing and examination. It was noted that the outlet coupons showed signs of erosion. It was determined that the outlet cassettes were installed in a somewhat higher velocity region in the outlet flue where the flow was not perpendicular to the cassettes causing erosive impingement of the ash upon the coupons. Normally, on the actual (full size) plates this impingement would affect a minor surface area but for the very short coupons the loose of catalyst made activity testing for these unreliable.
